Seabreeze Centerboards

by Roy Harvey, #127 *Aeolus*

REBUILDING AND REPAIRING ALUMINUM CENTERBOARD

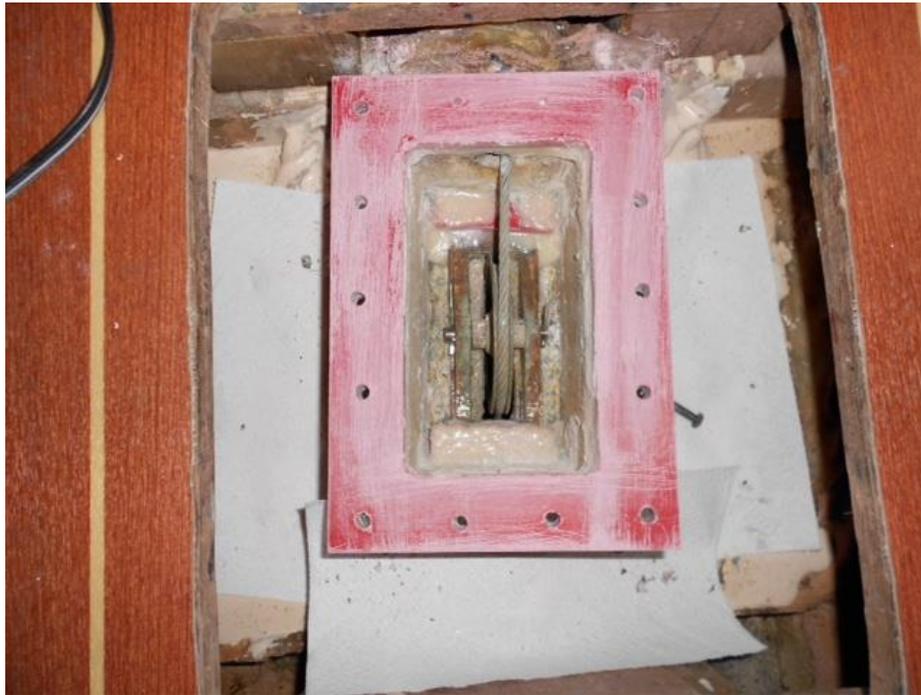
This photo shows the water tight box open with the sheave and cable exposed

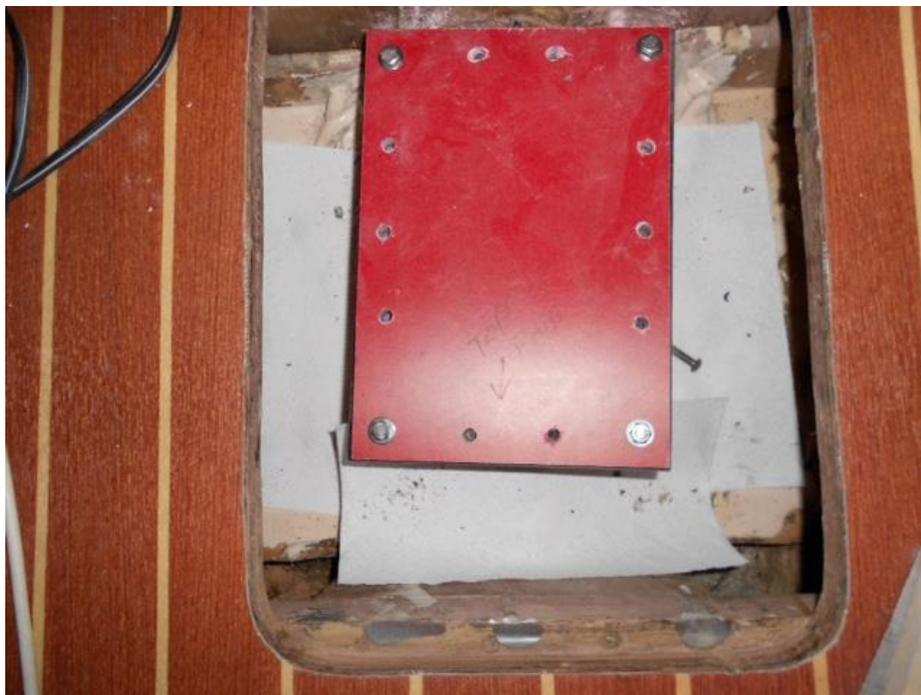
This photo shows the water tight box and lid, lid not bolted in place...this box and cover have been re-built by the owner to allow using a rubber gasket rather than caulking.
